Scan from McAllen Texas:  
 2002 A4 ECM and Instrument cluster scan, the customer keys were lost.

# ECM Adaptation

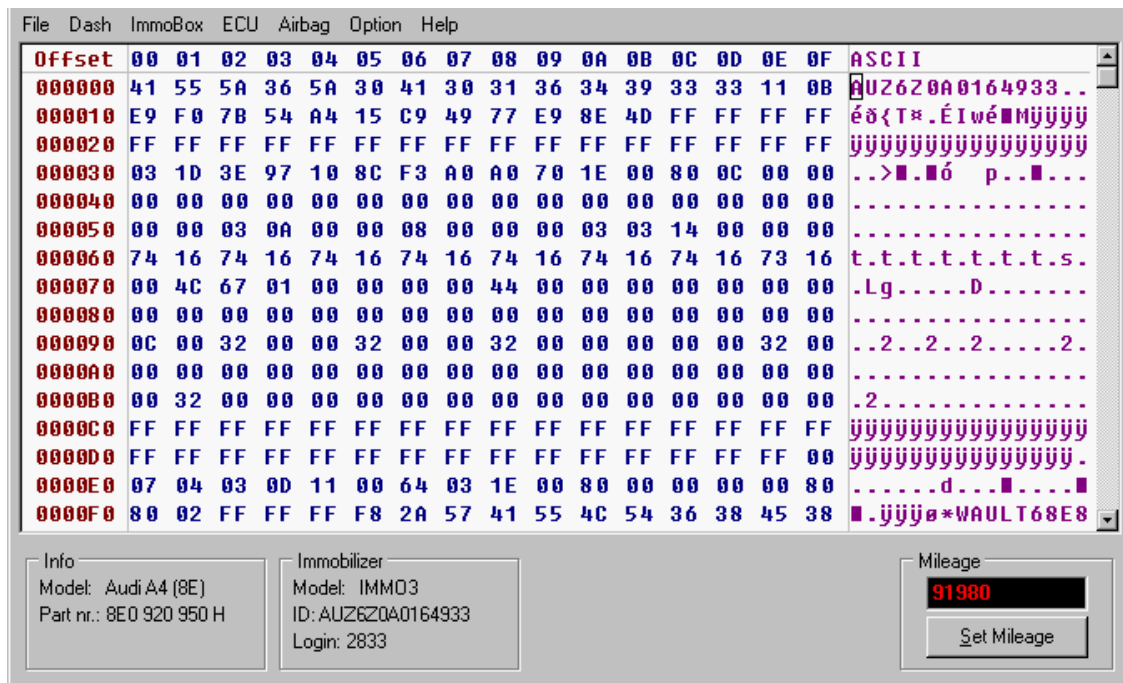
This is the Bosch cluster and it's indicated by the number RB4. This type of cluster has encryption built in and was difficult to acquire the PIN.  
 We tried various software/hardware combinations similar to the ones tried in College Station Texas with no luck.  
 Here's the solution for this software level on this cluster on figure 2 and 3.

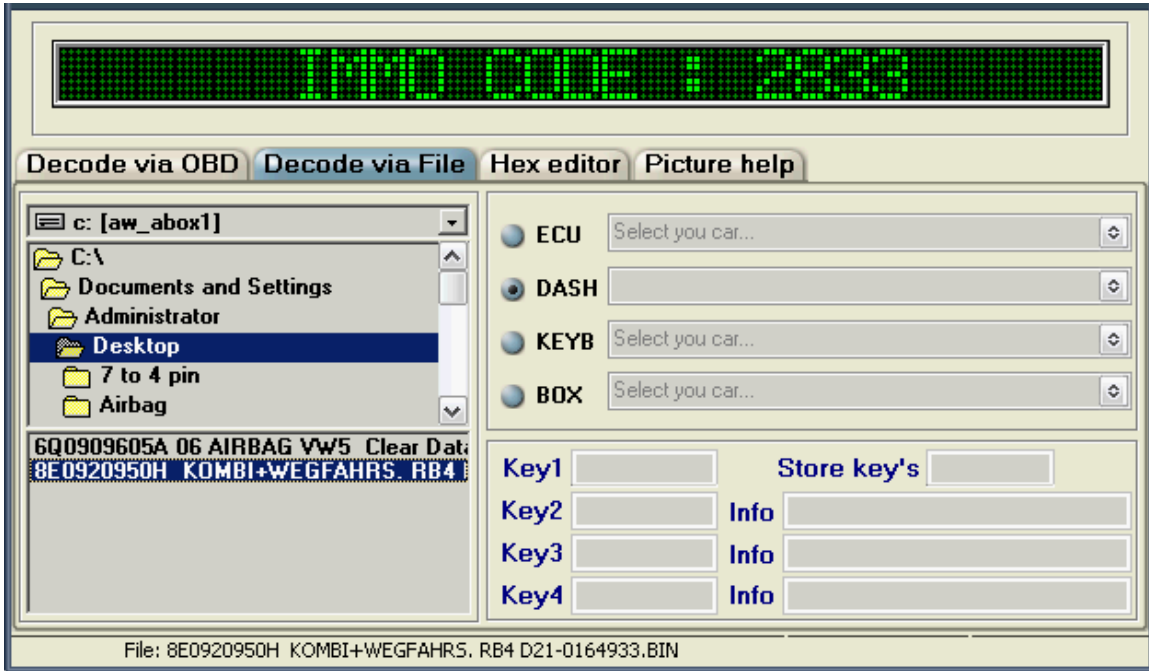
figure 3

Sometimes the technician would need to verify the acquired PIN before adapting any key, Instrument cluster or Engine controller. The next figure (3) indicates a match. This match is possible because a bin file was saved. The bin file is the data from this cluster. In figure 2, the hex values are run through a mathematical equation and the output is the data seen at the bottom of figure 2 and figure 3.

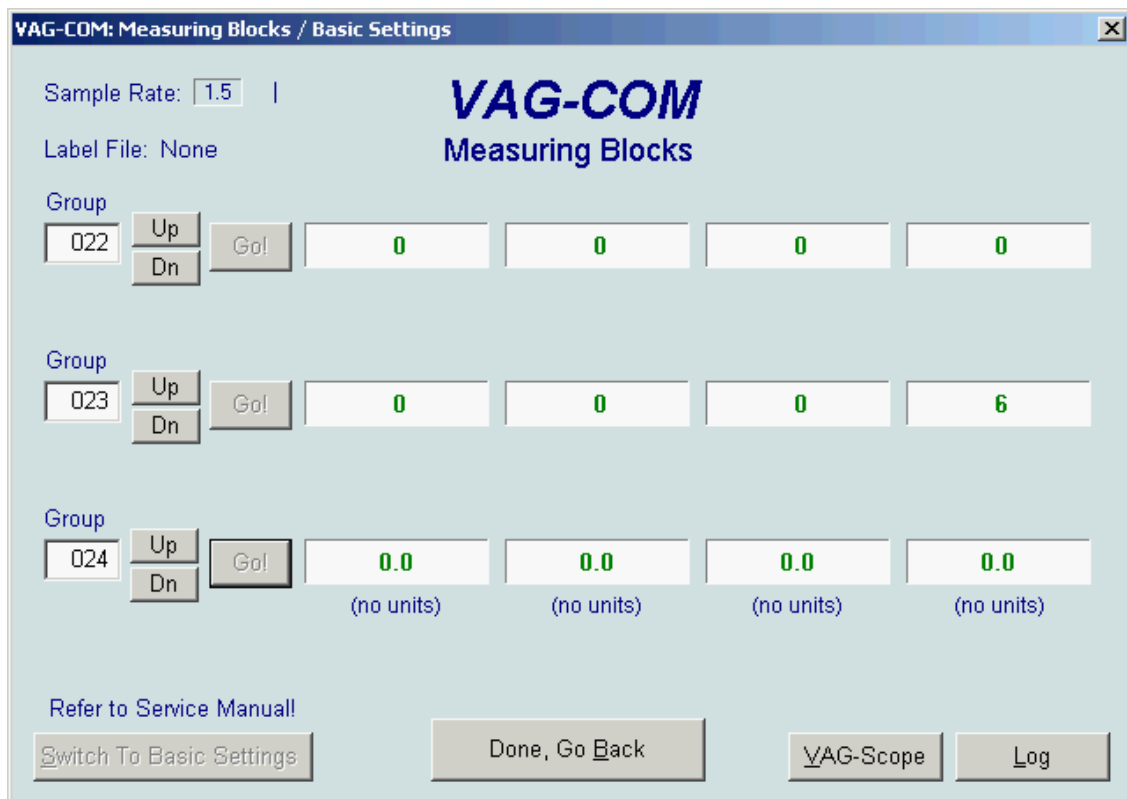
For the sake of speed and simplicity, Vag-Com is used to “adapt” the new components if the correct PIN is known and to display the data in this document. Figure 4 indicates that Immobilizer is ready and that the technician isn’t locked out. Any Vag style scan tool like a Vedis or iScan can complete the adaptation.

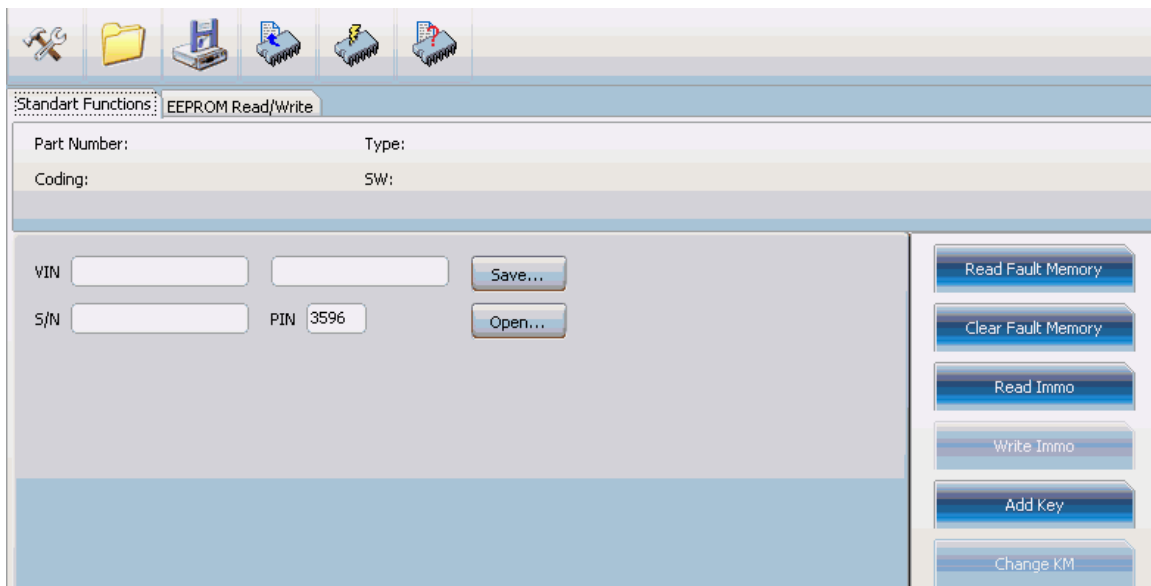
method 1

This would involve the cluster to be removed and connected to the RS232 line for encrypted communications. This PIN is now acquired as 3596. This cluster is described as reconditioned. That is because the last digit in the part number indicates an "X".

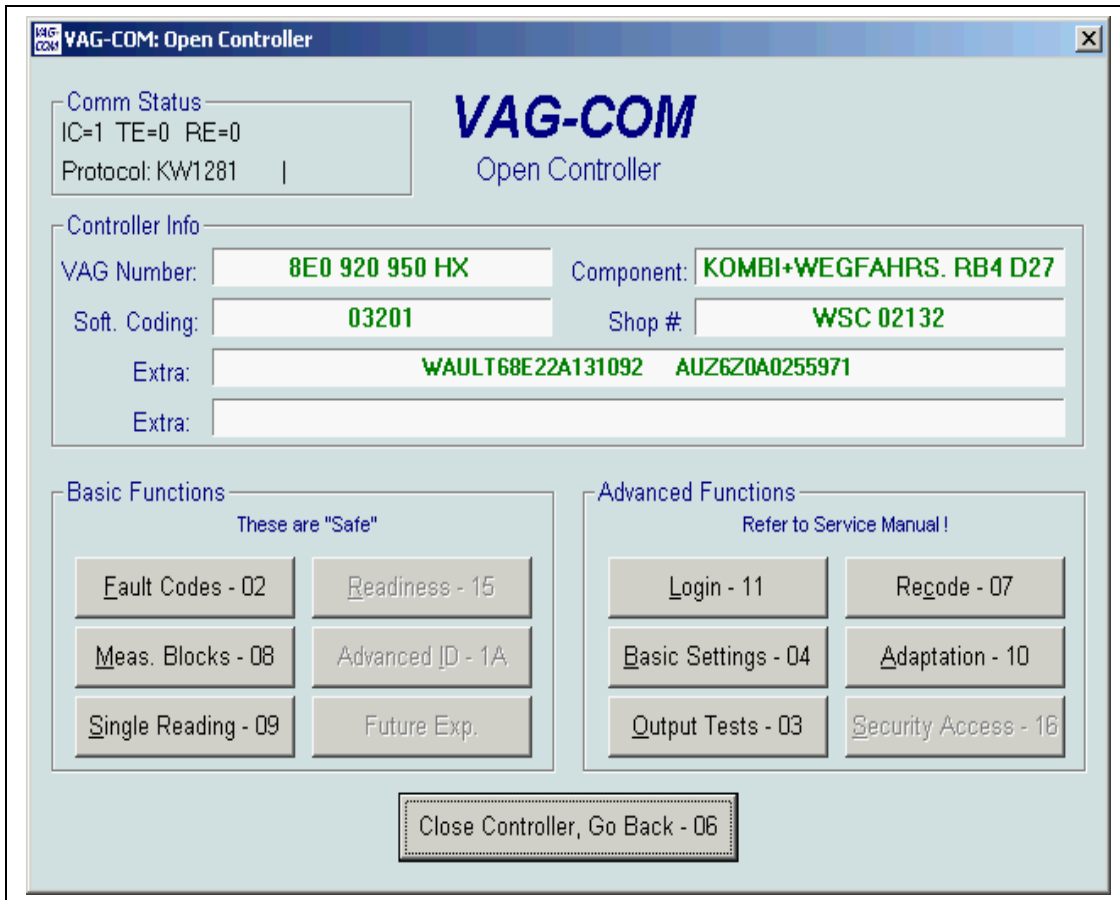
See the next Instrument cluster scan.

This is where the scans become important. It is the version and software level that will indicate if the cluster will produce the PIN at the repair facility as a field repair or if it needs to be sent to ESAT Inc to acquire the encrypted PIN for the facility.

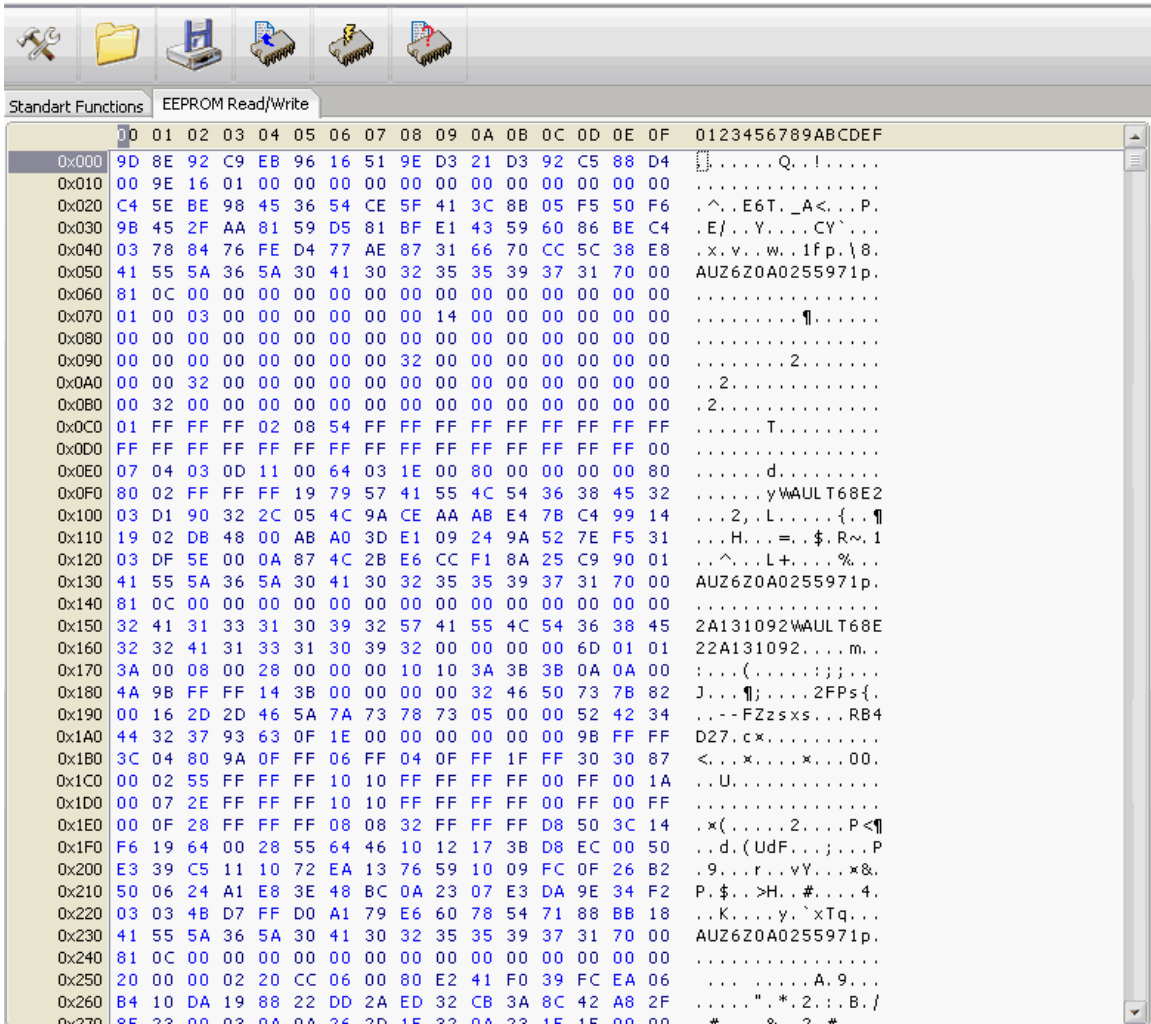
The next illustration is the encrypted data for the same cluster.

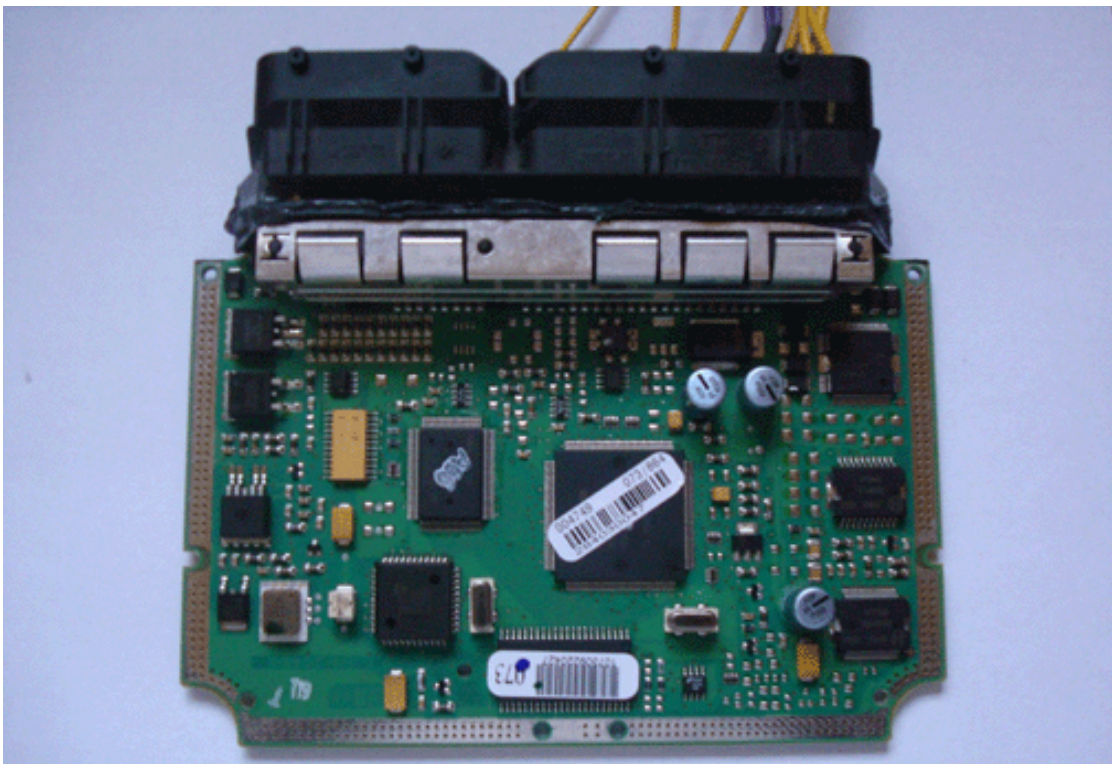
I have a Jetta TDi ECM and it only took 4 screws to open it. See this next figure.

Notice the wires, that's because there is no RS232 communication. It is ALL ON CAN. The next illustration is of the data from this ECM.

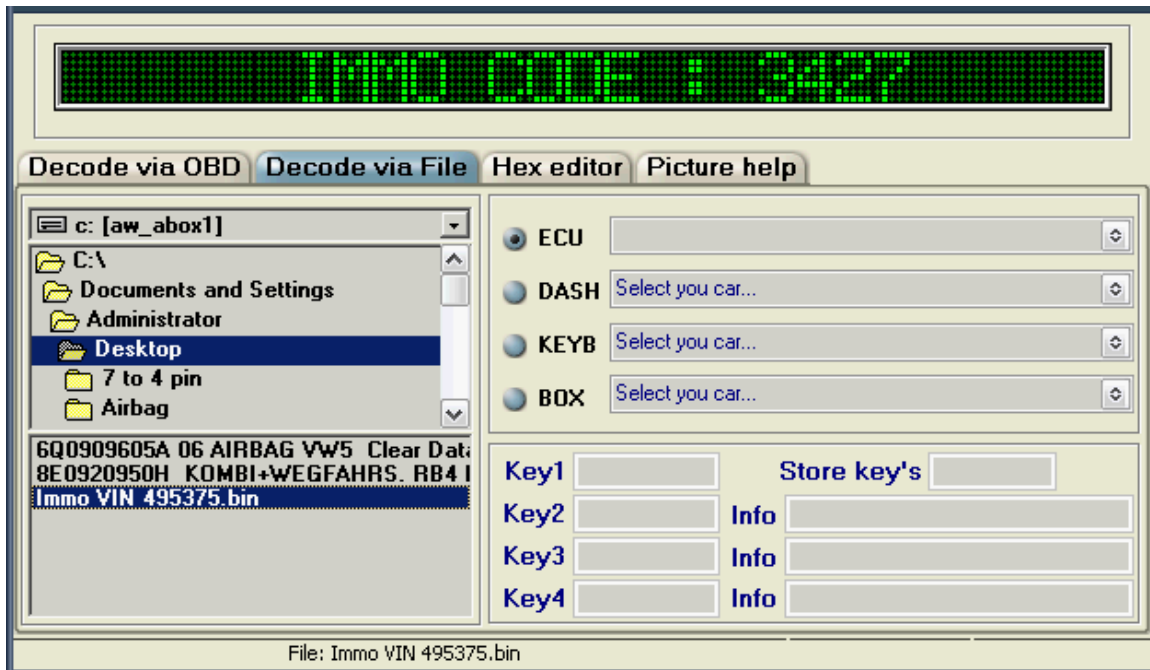
The next illustration indicates the PIN for this TDi ECM. Now that we know that, we were able to adapt a used 2002 A4 Bosch RB4 instrument cluster to a 2002 Jetta TDi used ECM. All that was required is recoding of the cluster to indicate the correct transmission. There's always someone saying it can't be done. I had to prove otherwise.
