Technical Service Bulletin

No drive or delayed drive in "D" or "R" (DTC P1743/18151 may be stored in TCM)

38 07 01 Jan 9, 2007, 2013280/1

Model(s)	Year	VIN Range	Vehicle-Specific Equipment
A6	2006-2007	All	With Automatic CVT (01J)
A4	2005	All	
A4 Cabriolet	2005-2006	All

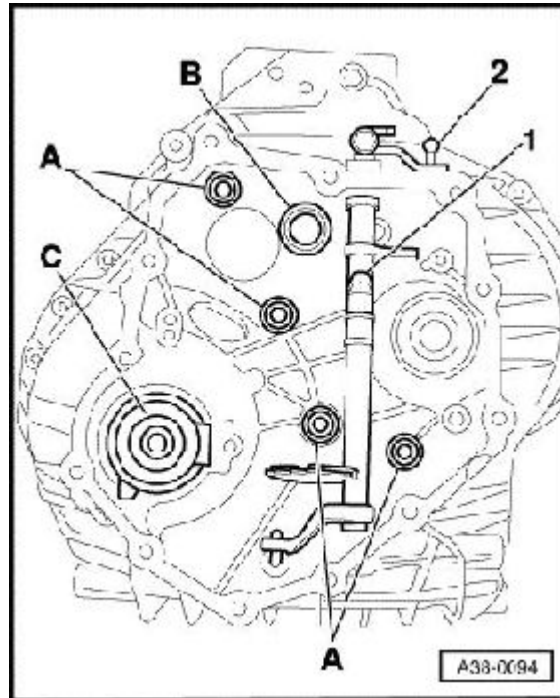
Figure 1.

Some damaged seals installed in production.

The damaged seals may leak after a short operating period (less than 13,000 miles), causing a loss of transmission oil pressure.

A. If the complaint occurs in **D** and **MVB10/1** is above 380 mA, replace only the 4 axial seals (**01J301547F**, as shown in Figure 1, A) at the valve body.
