These are a few screen captures of the coolant temp sensor on a 2005 TDI Jetta I repaired today using the Ease software.

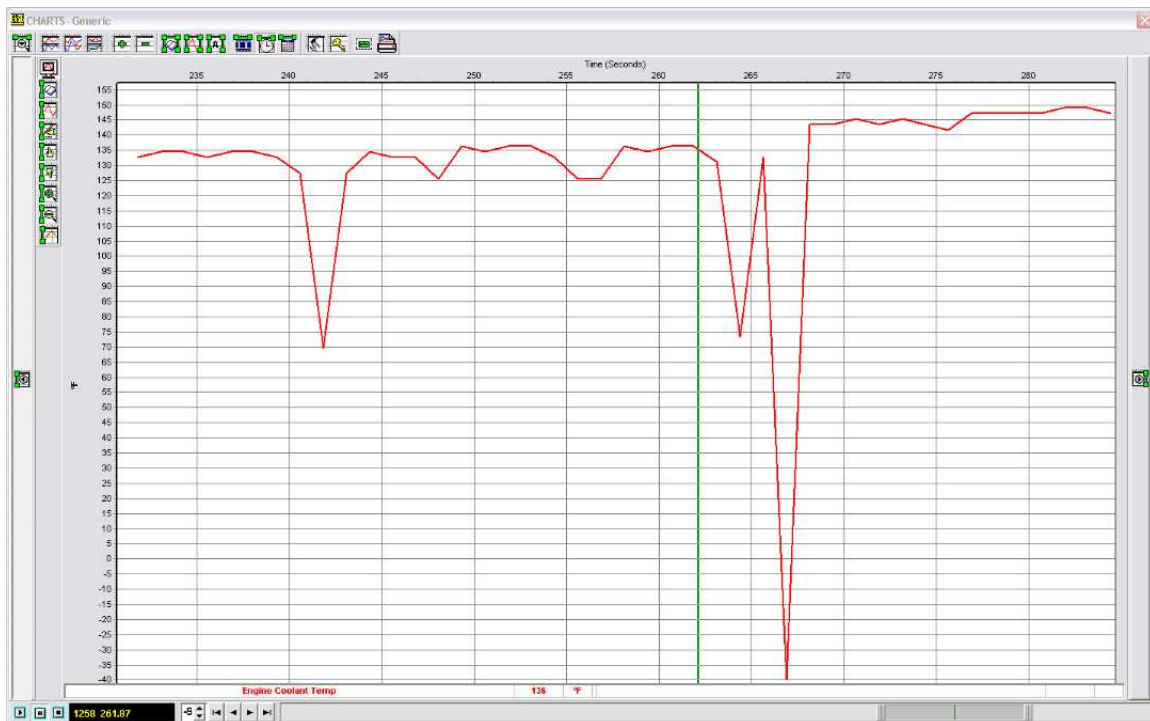
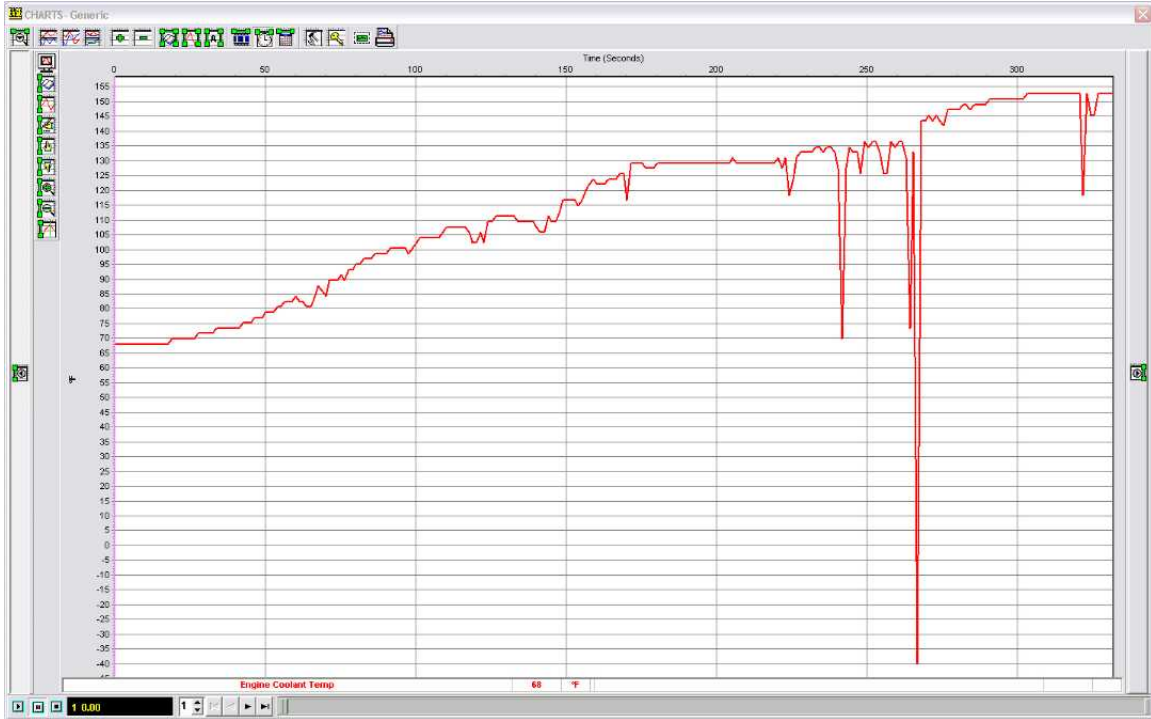
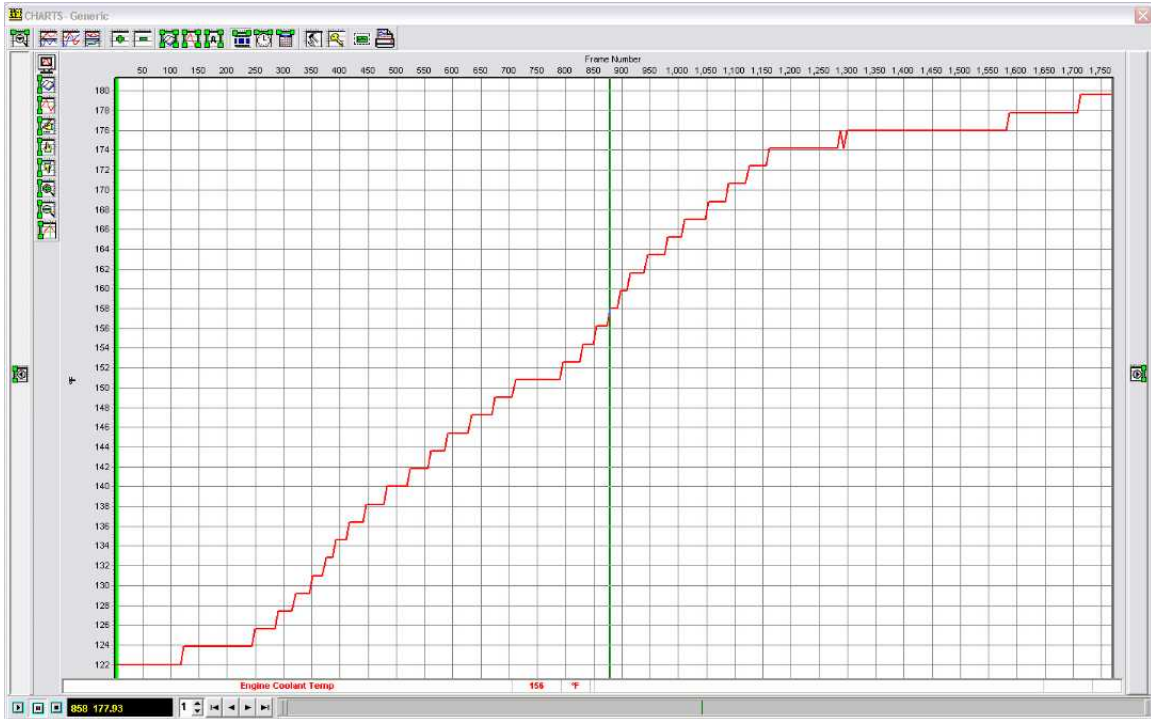
We presently use only sensors made in Spain from FAE. Check out the temp reading when the drop occurred.

This defective sensor was indeed the ominous "black" outdated sensor which I replaced with a "green". It is very important to know NOT to use sensors from Luxembourg, they have given us a ton of problems.
